Manhole Inspection Summary

Manhole # S21GG1018MH

Insp Date: **7/27/08 10:35 PM**

Location Address: **1453 MEDFIELD AVE**

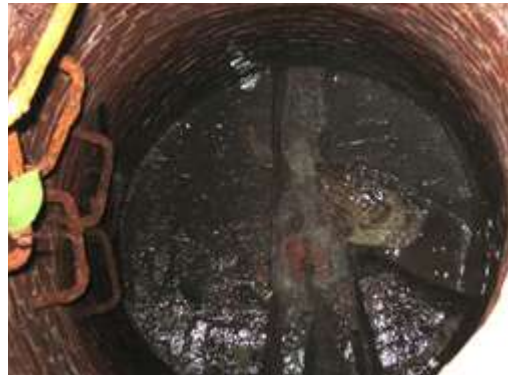
Top View

Corroded steps. Evidence of surcharge - Bench debris.

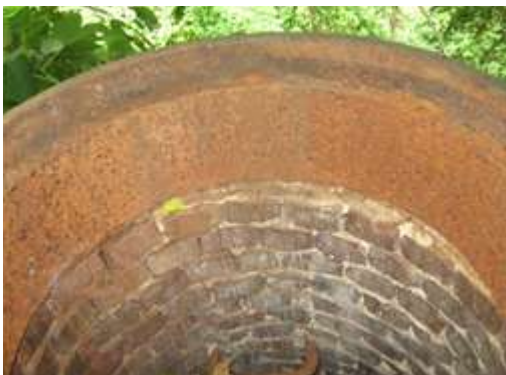
Defect

Condition: ☐ Sound ☐ Cracked ☐ Root Intrusion ☐ Loose Brick ☒ **Deteriorated**

Infiltration: ☐ None ☒ **Joint** ☐ Cracks ☒ **Mortar** ☐ Roots ☐ Wall

Adjustment deterioration and infiltration.

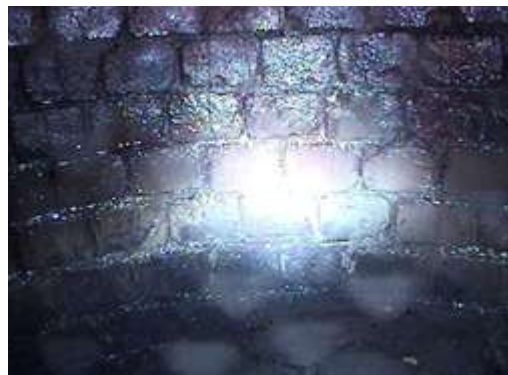
Defect

Barrel root intrusion and infiltration.

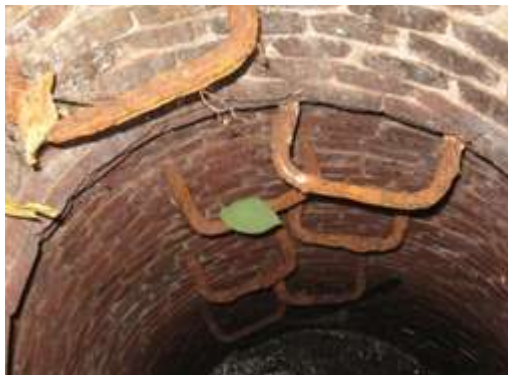
Defect

Infiltration: ☐ None ☐ Joint ☐ Cracks ☒ **Mortar** ☐ Roots ☒ **Wall**

Corbel and Barrel infiltration.

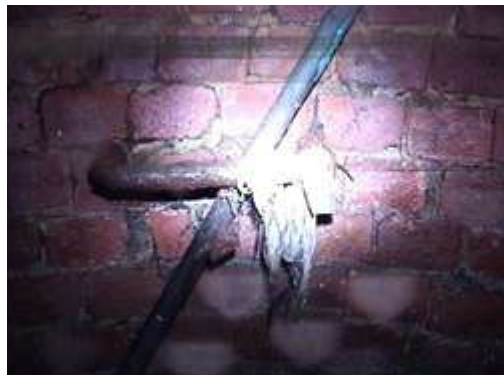
Defect

☒ **Evidence Of Surcharge** Depth: **4.5** (ft.) ☐ Active Surcharge Present

Evidence of surcharge.

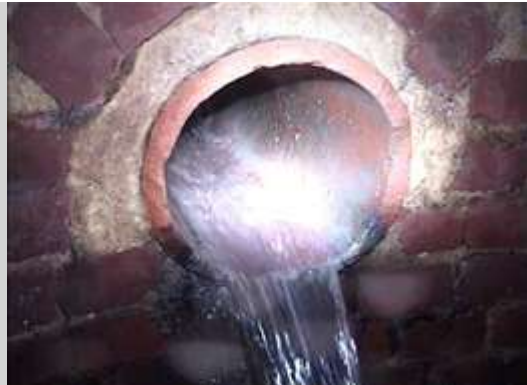
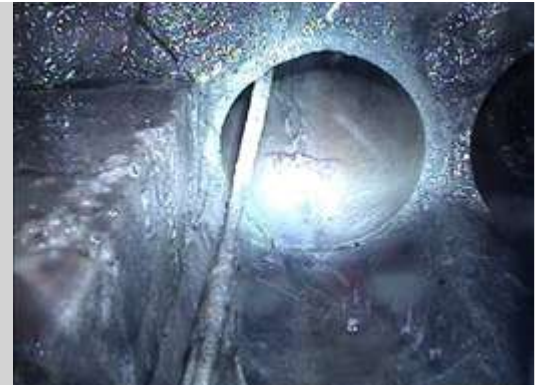
Drop In @ 5 O'Clock

Drop Condition: **Partly Clogged**
